Home Inspection Report

Saturday, April 22, 2017

Liberty Strategies LLC

144

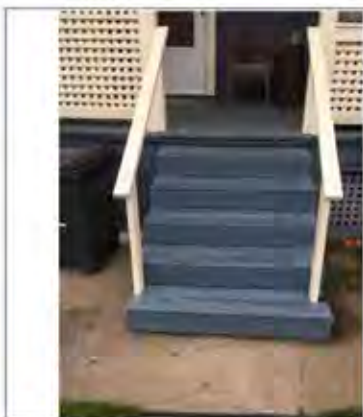
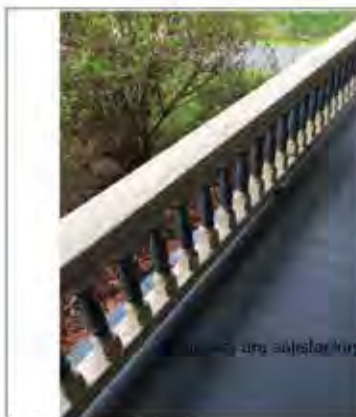
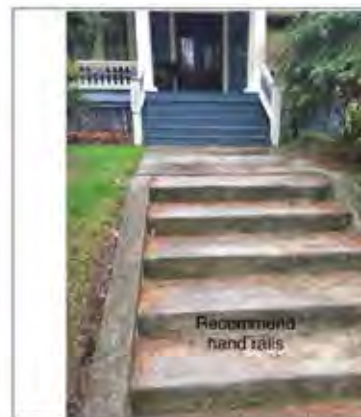
☐ None
Material ☐ Concrete ☒ Wood Other: ☒ Railing/Balusters recommended
Condition ☐ Satisfactory ☒ Marginal ☐ Poor ☐ Safety Hazard ☐ Uneven risers ☐ Rotted/Damaged
☐ Cracked ☐ Settled
Comments Recommend hand rail.

Recommend
hand rails

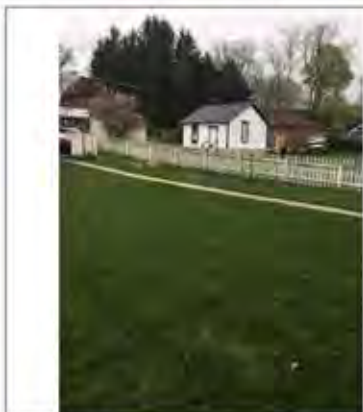
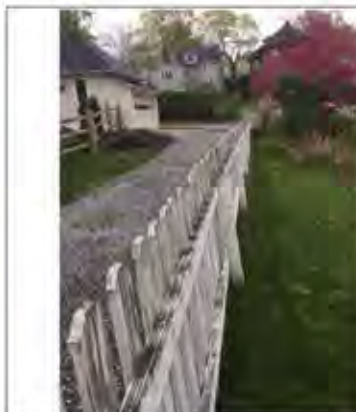
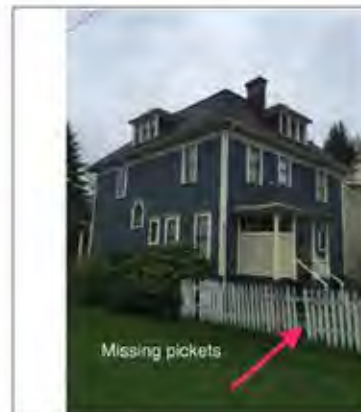
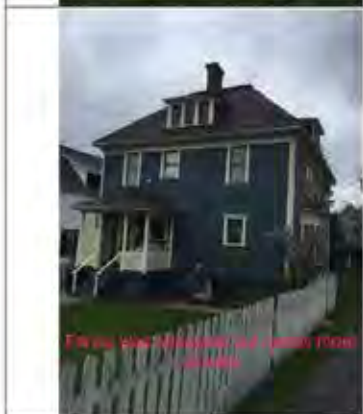
Missing pickets

Fence was functional but missing some pickets

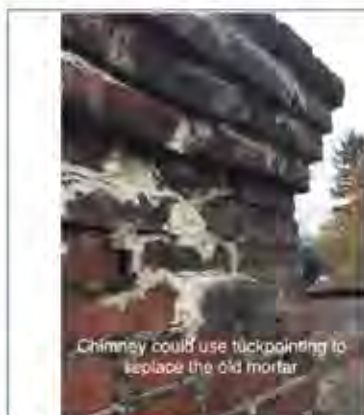
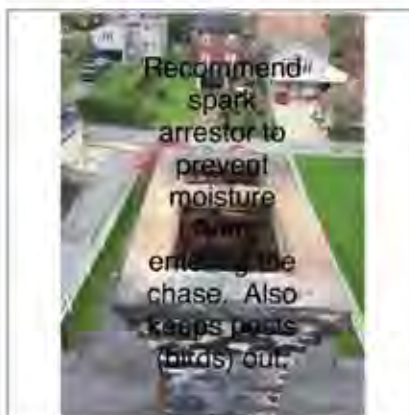
Comments Chimney had some minor defects but was overall satisfactory

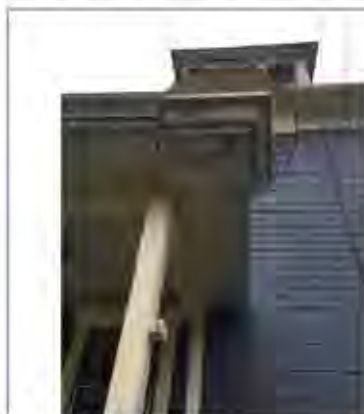
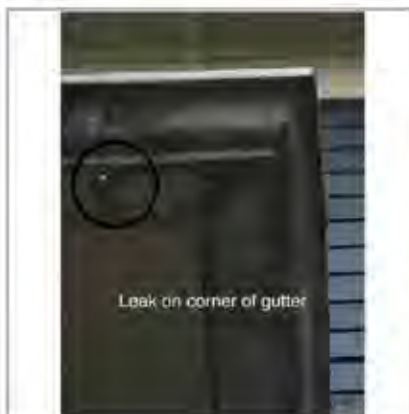
Comments Found a small leak on the corner of the rear porch.

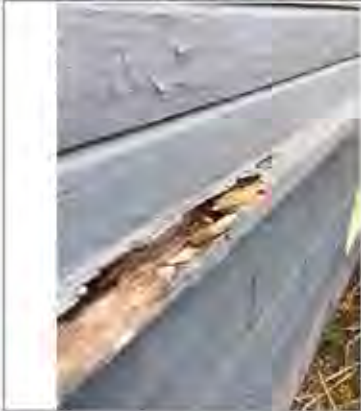
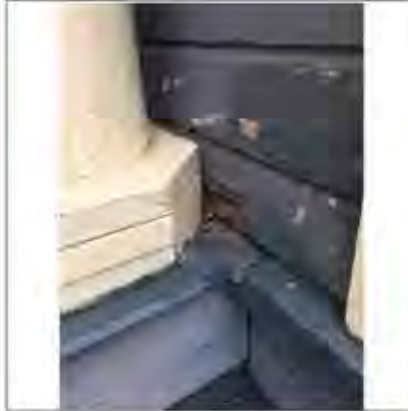
Material cont. ☐ Loose/Missing/Holes
Condition ☐ Satisfactory ☒ Marginal ☐ Poor ☒ Recommend repair/painting
Comments Siding was considered marginal but was functioning.
Photos

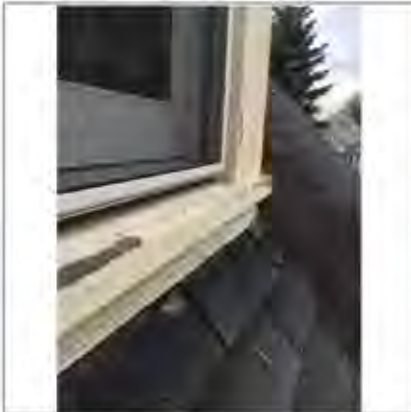
Material ☒ Wood ☐ Fiberboard ☐ Aluminum/Steel ☐ Vinyl ☐ Stucco ☒ Recommend repair/painting
☐ Damaged wood Other:
Condition ☐ Satisfactory ☒ Marginal ☐ Poor
Comments Trim had some deterioration recommend repair and painting
Photos

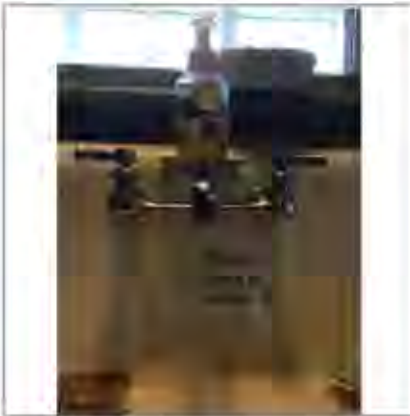
Comments Faucet leaked. Kitchen overall satisfactory.

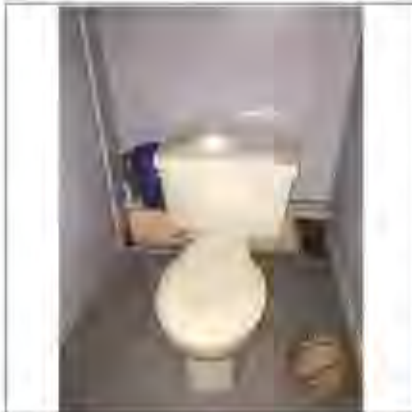
Comments Basement only had a toilet... flush mechanism was not functioning.

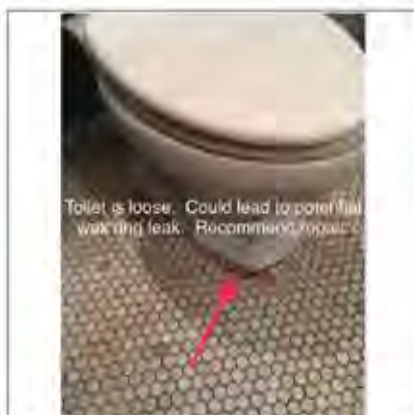
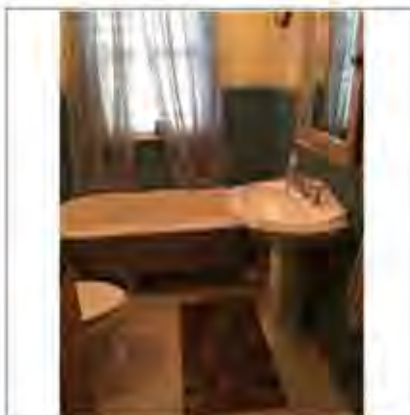
Comments Toilet bowl is loose recommend sealing properly to prevent damage to wax ring.

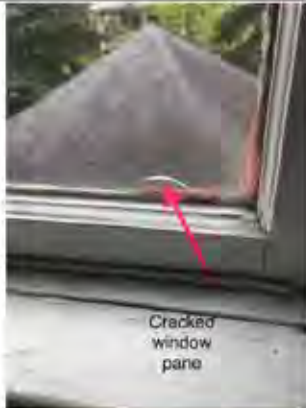
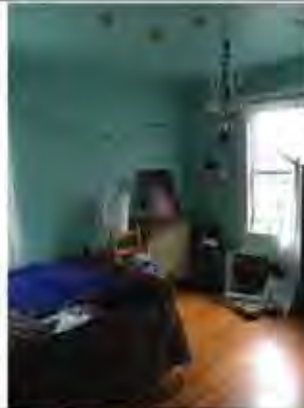
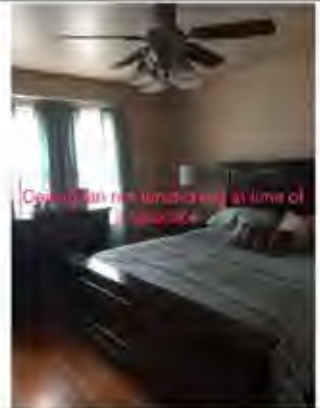
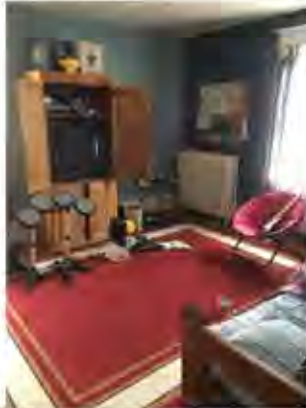
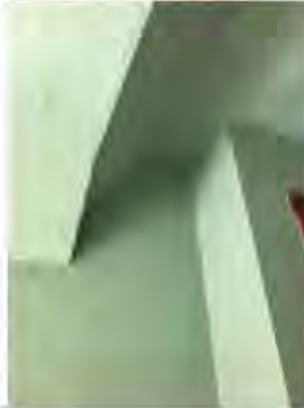
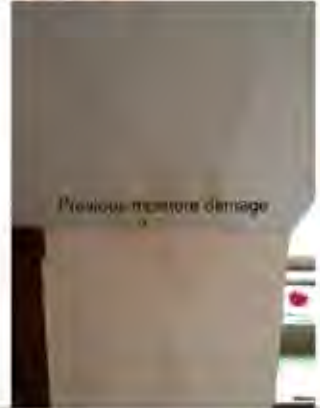
Moisture stains ☒ Yes ☐ No
Where:
Ceiling from previous moisture intrusion.

Comments Common rooms were in overall adequate condition. Minor defects noted.

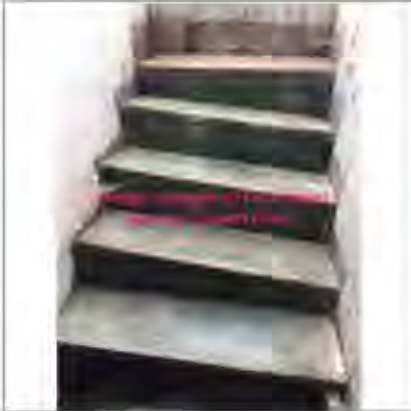
Condition ☐ Satisfactory ☐ Marginal ☒ **Poor** ☐ Typical wear and tear ☐ Need repair ☒ Risers Uneven
☐ Safety Hazard

Handrail ☐ Yes ☒ No Condition: ☐ Satisfactory ☐ Loose ☒ Handrail/Railing/Balusters recommended

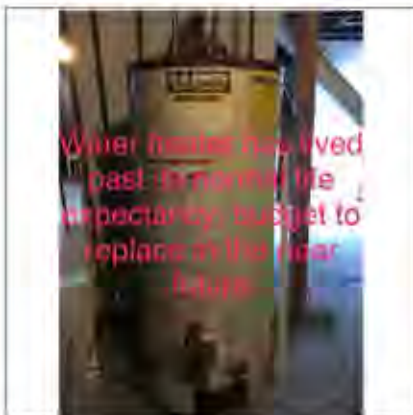
☐ N/A
General Brand Name: A.O. Smith
 Capacity: 40
 Approx. age: 22 years old
Type ☒ Gas ☐ Electric ☐ Oil ☐ LP Other:
Combustion air venting present ☒ Yes ☐ No ☐ N/A
Relief valve ☒ Yes ☐ No Extension proper: ☒ Yes ☐ No ☐ Missing ☐ Recommend repair ☐ Improper material
Vent pipe ☐ N/A ☒ Satisfactory ☐ Pitch proper ☐ Improper ☐ Rusty ☐ Recommend repair
Condition ☐ Satisfactory ☒ Marginal ☐ Poor
Comments Water heater has lived past its normal life expectancy and should be monitored. Budget to replace in the near future.

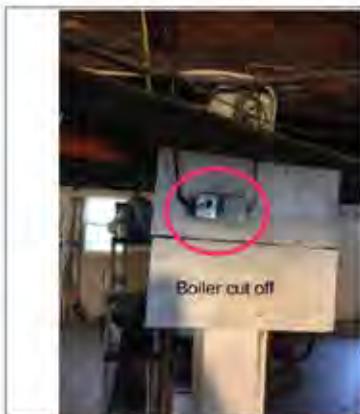
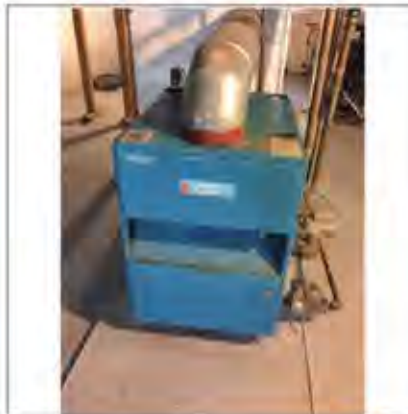
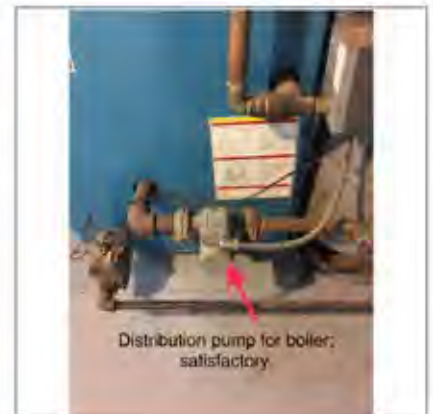
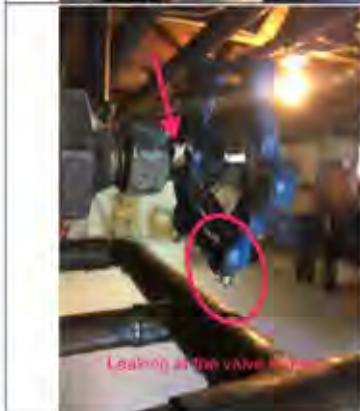
Comments Boiler was in overall satisfactory condition. Valve had a thread leak.
