LIBERTY
INSPECTORS

Home Inspection Report

Wednesday, January 6, 2021

3008

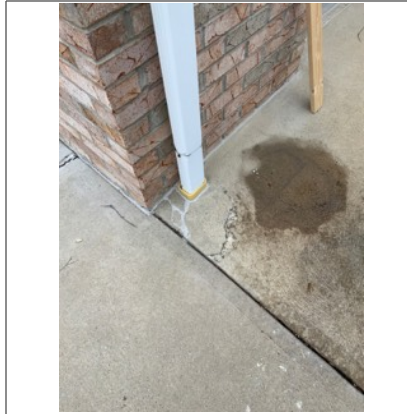
Material ☐ None ☐ Not Visible
☒ Concrete ☐ Flagstone ☐ Gravel ☐ Brick Other: _____
Condition ☐ Satisfactory ☒ Marginal ☐ Poor ☒ Trip hazard ☐ Typical cracks ☐ Pitched towards home
☐ Settling cracks ☐ Public sidewalk needs repair
Comments Uneven slabs in walks, could pose a potential tripping hazard, repairs are recommended. (South walkway near deck entry)
Photos

Uneven slabs in South walkway could pose a tripping concern

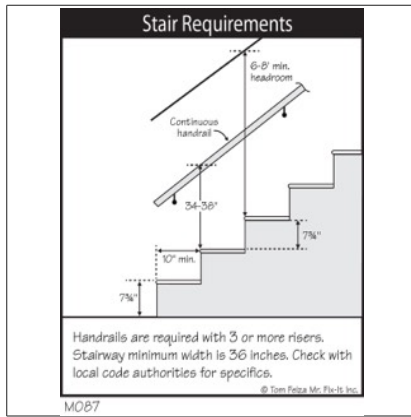
No handrail was installed for stairs or steps with 3 or more risers. For improved safety, a handrail should be installed at all stairs and steps with 3 or more risers. Lack of properly installed stairway handrails is a SAFETY HAZARD.

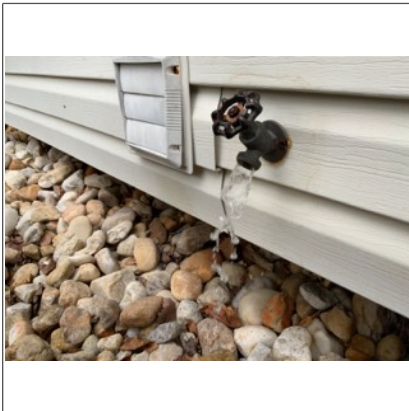
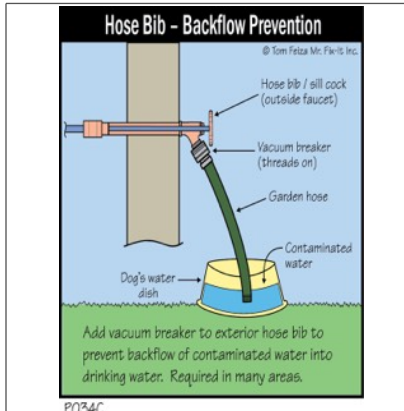
Exterior water supply faucets were missing an anti-siphon device to prevent contaminants from entering the water supply. Lack of anti-siphon devices at exterior water supply faucets is a SAFETY HAZARD.

Recommend in winter to shut off valve on the inside of the house and open the outside faucet to allow drainage and to prevent freezing.

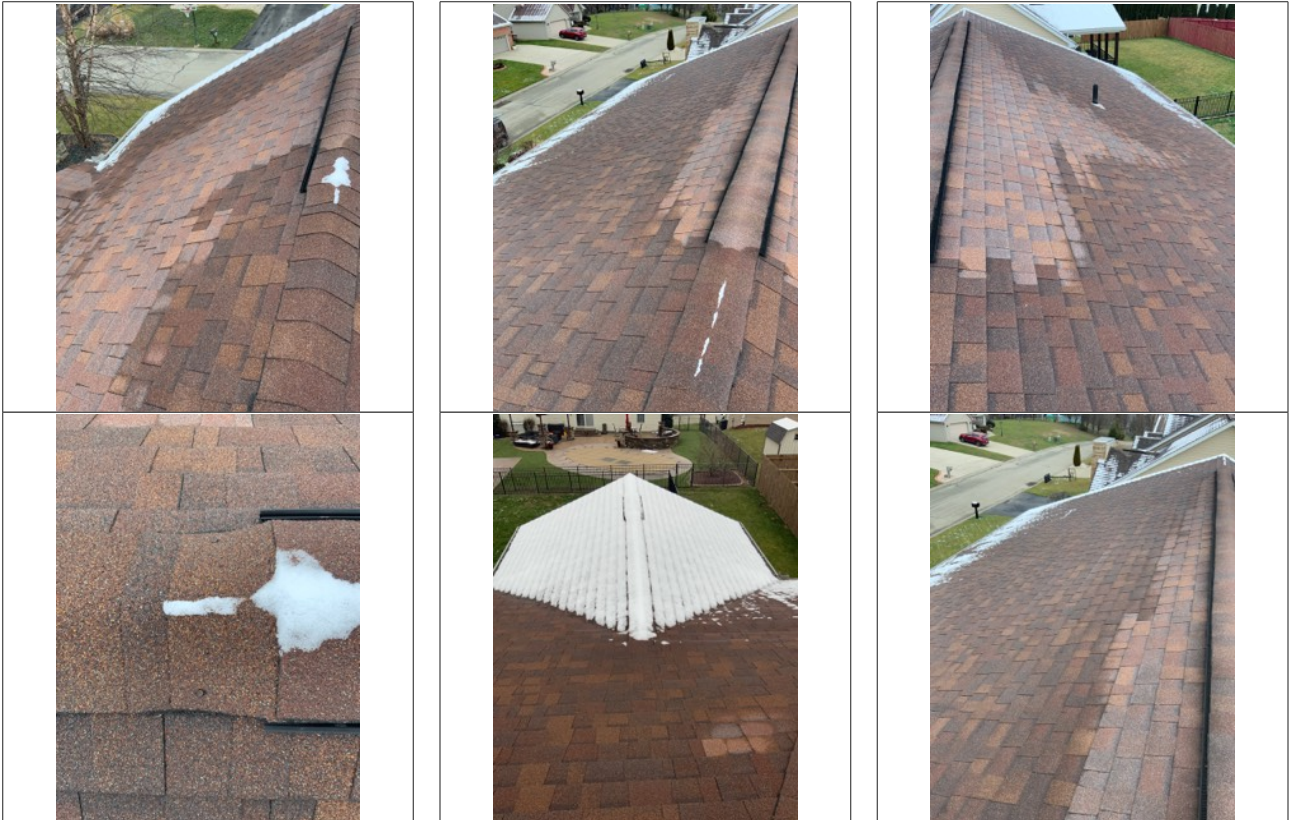
Deflection or sagging of the roof surface was observed on north roof near valley. The cause of deflected or sagging roof surfaces and or decking should be determined and repaired as needed by a qualified specialist. (North eave above entry)

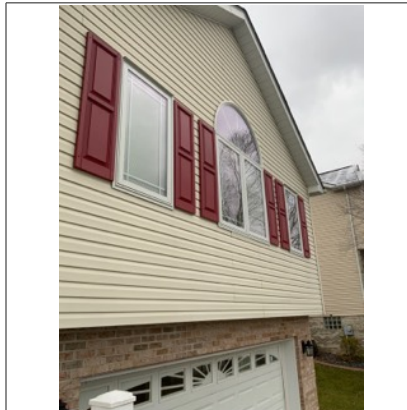
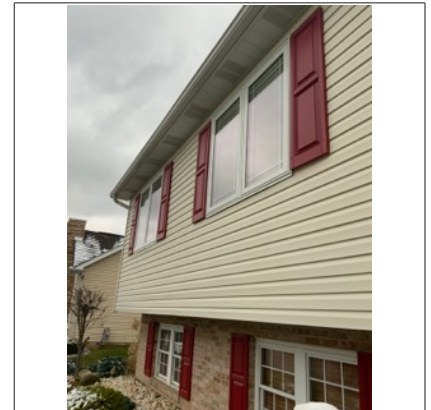
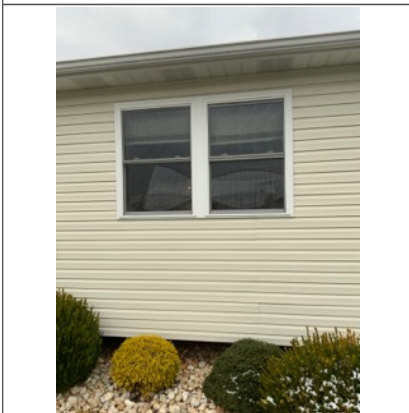
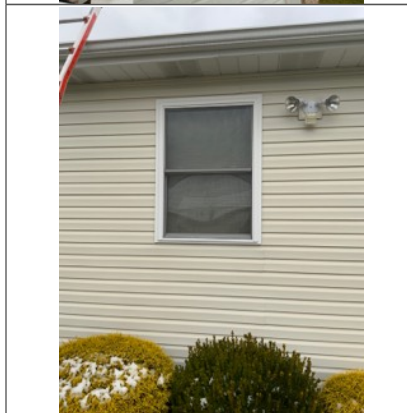
Comments Some screens are torn recommend repair
Photos

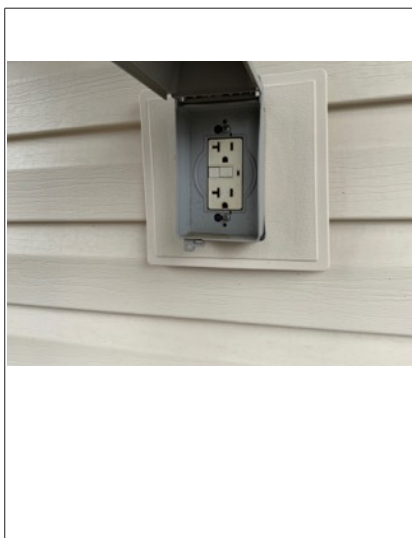
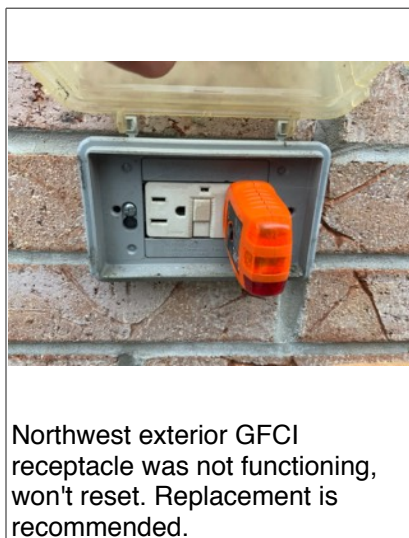
Comments Northwest exterior GFCI receptacle was not functioning, won't reset. Replacement is recommended.
 Photos

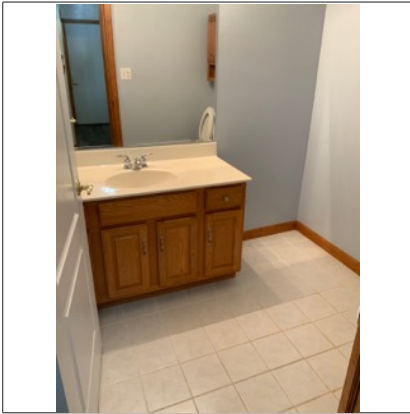
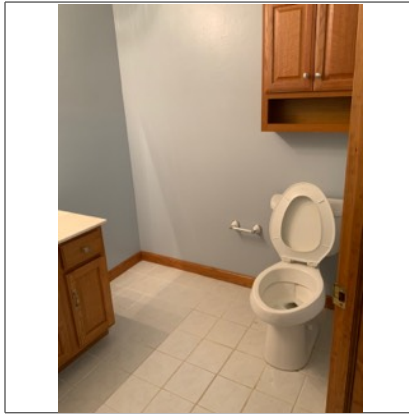
Toilet water runs which is an indication that water valves, flappers or other components are in need of repair or replacement.

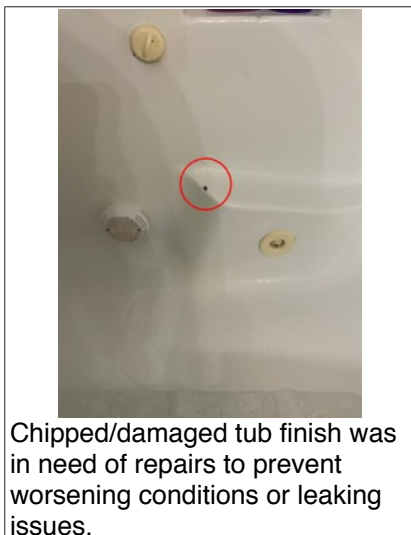
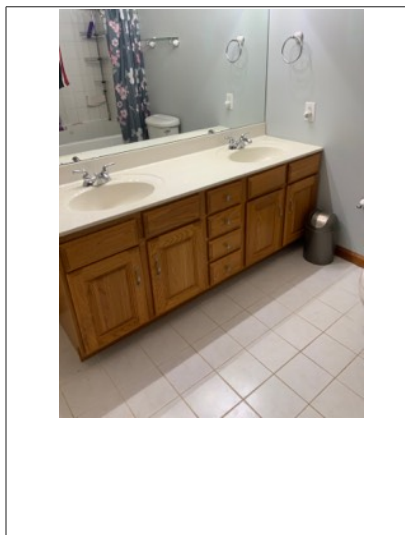
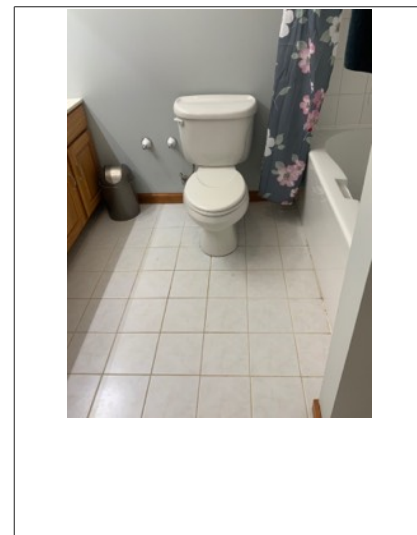
Comments Chipped/damaged tub finish was in need of repairs to prevent worsening conditions or leaking issues. Cracks/damage washbasin master bathroom was in need of repairs.
