Home Inspection Report

Saturday, April 22, 2017

Liberty Strategies LLC

144

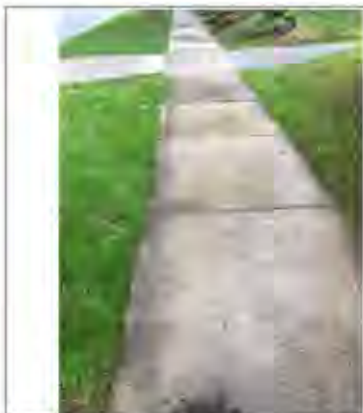
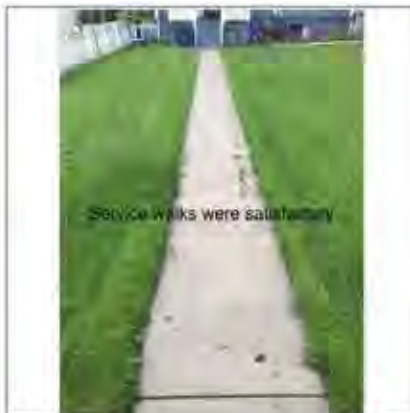
☐ None ☐ Not Visible
Material ☒ Concrete ☐ Flagstone ☐ Gravel ☐ Brick Other:
Condition ☒ Satisfactory ☐ Marginal ☐ Poor ☐ Trip hazard ☒ Typical cracks ☐ Pitched towards home
☐ Settling cracks ☐ Public sidewalk needs repair
Comments Walk ways were overall satisfactory.

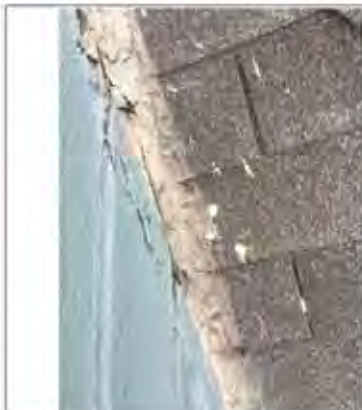
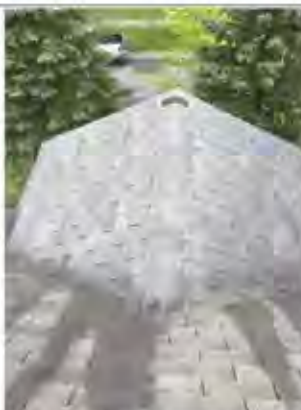
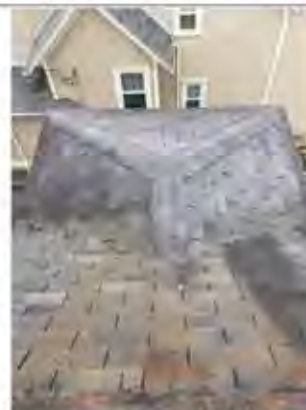
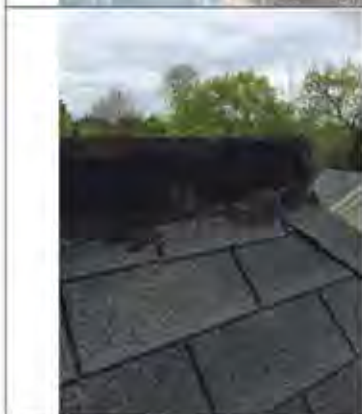
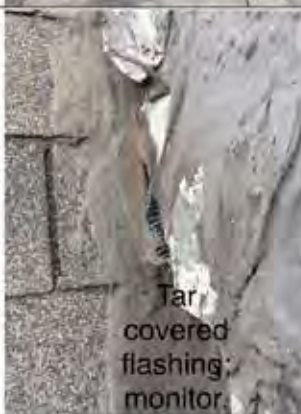
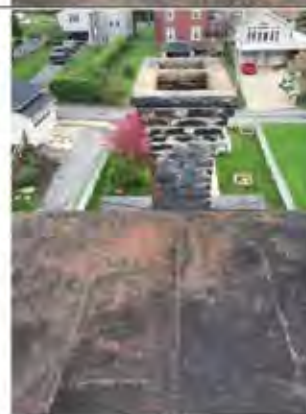
Roof #1 ☒ Satisfactory ☐ Marginal ☐ Poor ☐ Curling ☐ Cracking ☐ Ponding ☐ Burn Spots

☐ Broken/Loose Tiles/Shingles ☐ Nail popping ☒ Granules missing ☐ Alligatoring ☐ Blistering

☒ Missing Tabs/Shingles/Tiles ☐ Moss buildup ☐ Exposed felt ☐ Cupping

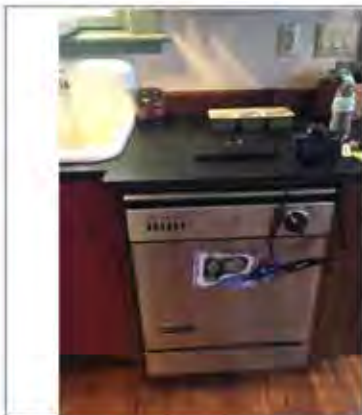
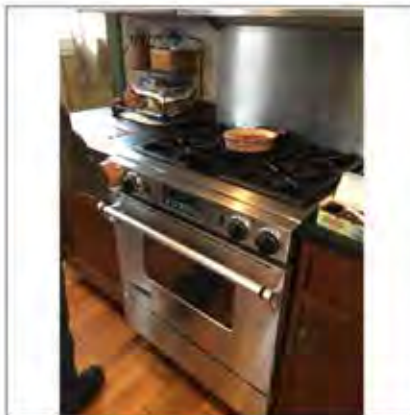
GFCI ☒ Yes ☐ No Operable: ☒ Yes ☐ No Recommend GFCI Receptacles: ☒ Yes ☐ No

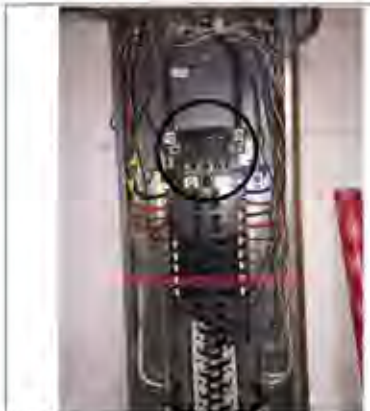
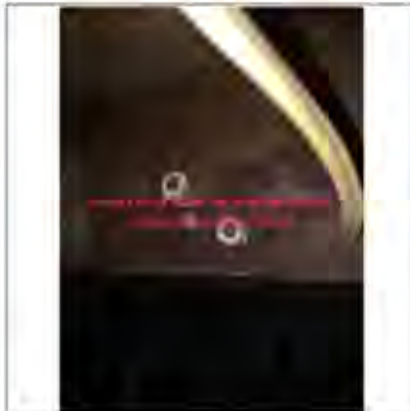
Location Basement
Condition ☒ Satisfactory ☐ Poor
Adequate Clearance to Panel ☒ Yes ☐ No
Amperage/Voltage ☐ Unknown ☐ 60a ☐ 100a ☐ 150a ☒ 200a ☐ 400a ☐ 120v/240v
Breakers/Fuses ☒ Breakers ☐ Fuses
Appears grounded ☒ Yes ☐ No ☐ Not Visible
GFCI breaker ☐ Yes ☒ No Operable: ☐ Yes ☐ No
AFCI breaker ☐ Yes ☒ No Operable: ☐ Yes ☐ No ☐ Not Tested
Main wire ☐ Copper ☒ Aluminum ☐ Not Visible ☐ Double tapping of the main wire
 Condition: ☒ Satisfactory ☐ Marginal ☐ Poor
Branch wire condition ☒ Satisfactory ☐ Poor ☐ Recommend electrician evaluate/repair ☒ Romex ☐ BX cable
☐ Conduit ☐ Knob/Tube ☐ Double tapping ☐ Wires undersized/oversized breaker/fuse
☐ Panel not accessible ☐ Not evaluated
 Reason:
Branch wire ☒ Copper ☐ Aluminum ☐ Solid Branch Aluminum Wiring ☐ Not Visible ☐ Safety Hazard
Comments
Photos
