LIBERTY
INSPECTORS

Home Inspection Report

Wednesday, January 6, 2021

3008

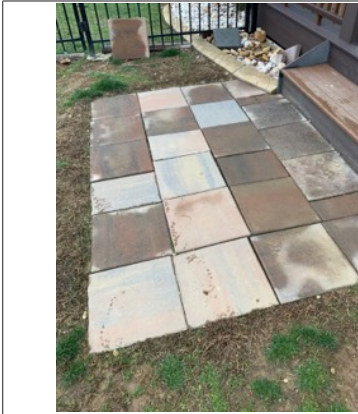
Uneven slabs in walks, could pose a potential tripping hazard, repairs are recommended. (South walkway near deck entry)

Uneven slabs in South walkway could pose a tripping concern

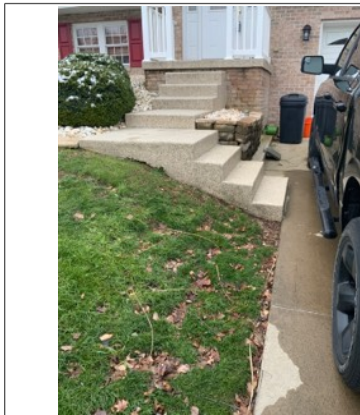
No handrail was installed for stairs or steps with 3 or more risers. For improved safety, a handrail should be installed at all stairs and steps with 3 or more risers. Lack of properly installed stairway handrails is a SAFETY HAZARD.

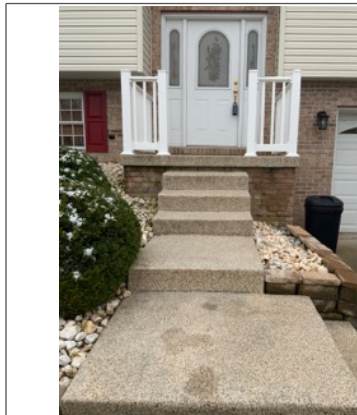
No handrail was installed for stairs or steps with 3 or more risers. For improved safety, a handrail should be installed at all stairs and steps with 3 or more risers. Lack of properly installed stairway handrails is a SAFETY HAZARD.

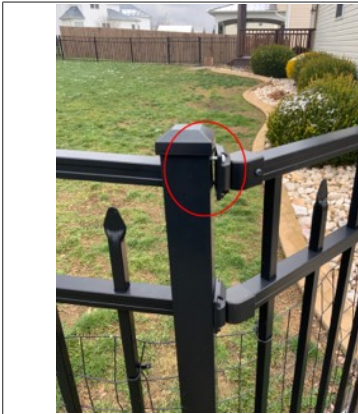
Top rail on the east fence was in need of minor repairs. Separation observed from top rail to supporting post.

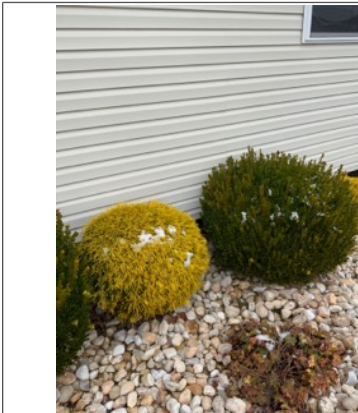
The vegetation is encroaching on the structure, and should be kept at a minimum of 12 inches away from the foundation and exterior walls.

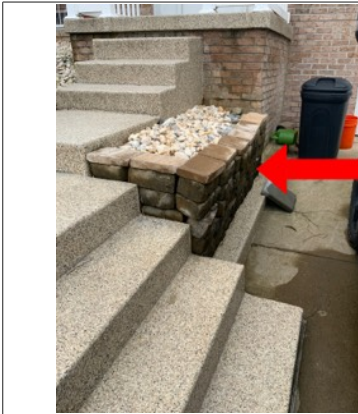
Retaining wall was leaning and had areas of separation at the block joints, recommend repair.

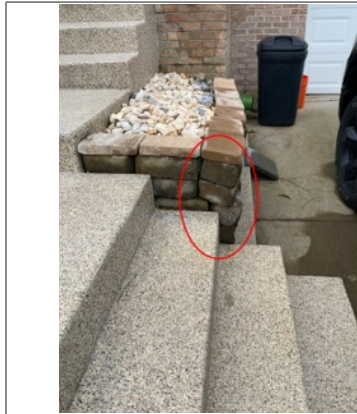
Retaining wall was leaning and had areas of separation at the block joints, recommend repair.

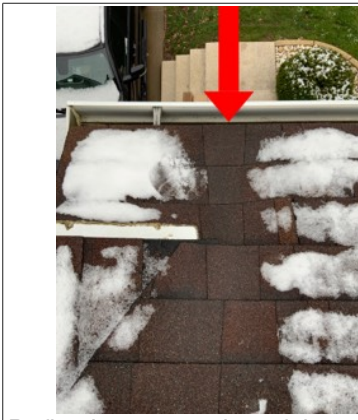
Deflection or sagging of the roof surface was observed on north roof near valley. The cause of deflected or sagging roof surfaces and or decking should be determined and repaired as needed by a qualified specialist. (North eave above entry)

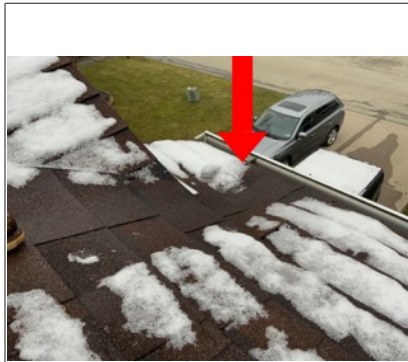
Deflection or sagging of the roof surface was observed on north roof near valley. The cause of deflected or sagging roof surfaces and or decking should be determined and repaired as needed by a qualified specialist. (North eave above entry)

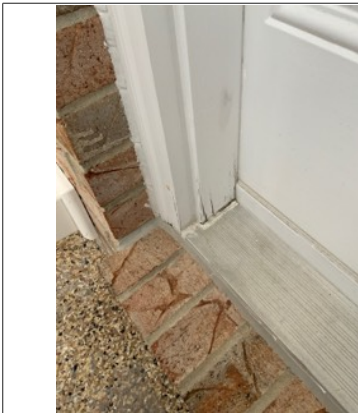
Wood trim was in need of normal painting maintenance.

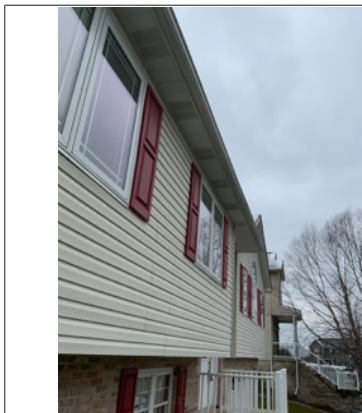
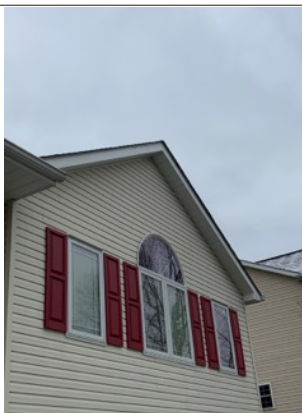
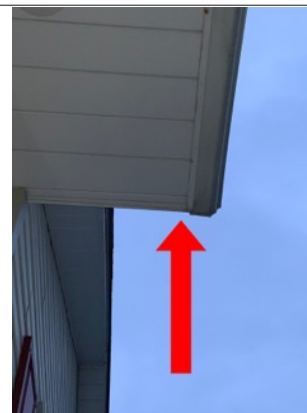
Water stains/leaking were observed at the soffit or eaves that may be an indication of water penetration through the roof covering. The cause of water stains at the soffit or eaves should be determined and repaired as needed by a certified, licensed roof covering specialist. (North exterior near entry)

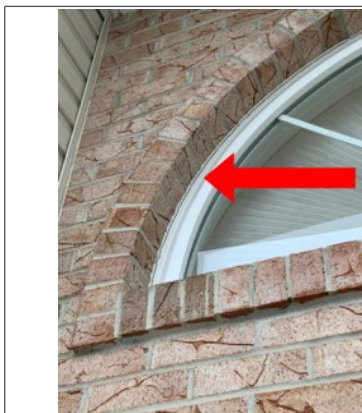
Exterior sealants (caulking) were deteriorated or missing in some areas. Sealants applied in appropriate locations prevent moisture intrusion.

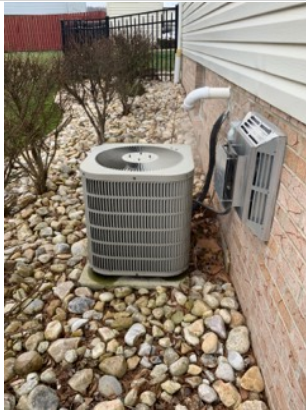
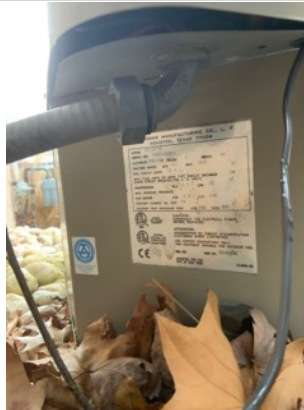
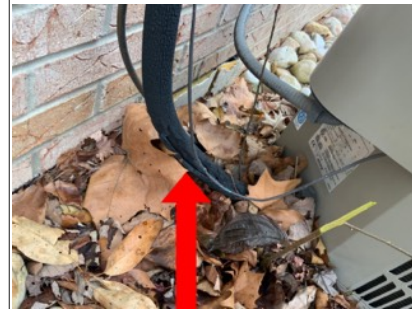
Exterior condenser unit is nearing its manufactured life expectancy but shows no signs of failure. Recommend serving unit and budgeting for replacement.

Recommend trimming back bushes from around the condenser unit.

The HVAC refrigerant lines were not properly insulated or the insulation was damaged and in need of replacement at the exterior equipment. Inadequate cooling line insulation at the exterior HVAC equipment may result in equipment damage, inadequate performance, reduced equipment life or other defects.

The HVAC refrigerant lines were not properly insulated or the insulation was damaged and in need of replacement at the exterior equipment.

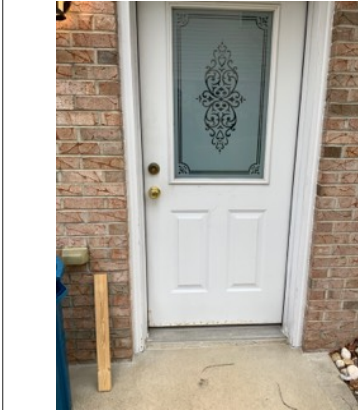
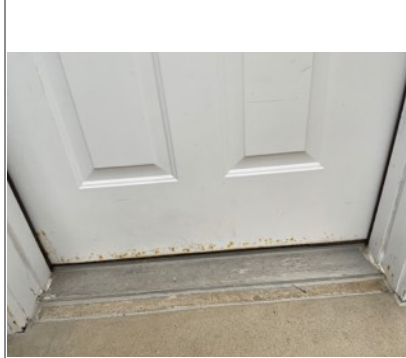
☐ None
Condition ☐ Satisfactory ☒ Marginal ☐ Poor ☒ Damaged/Rusted
Comments Minor rusting was observed on exterior service door
Photos

Minor rusting was observed on exterior service door

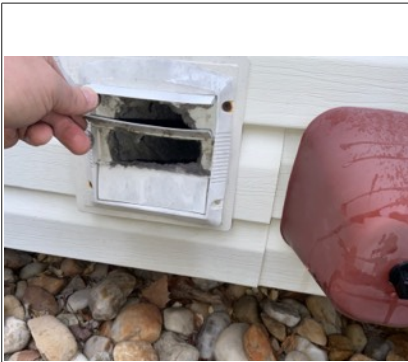
Comments The dryer vent and duct were in need of cleaning. Flammable lent and other debris should be removed from the dryer vent and duct for reasons of SAFETY.
 Dryer was set up for electric supply.

The dryer vent and duct were in need of cleaning. Flammable lent and other debris should be removed from the dryer vent and duct for reasons of SAFETY.

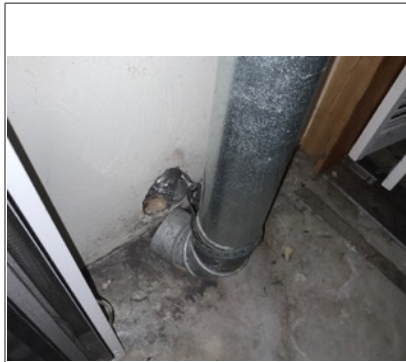
Separated dryer vent at wall connection

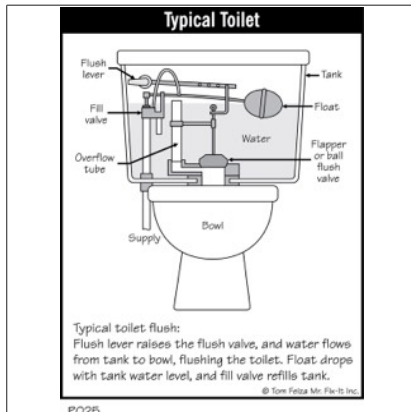
Bowl loose: ☐ Yes ☒ No Operable: ☒ Yes ☐ No ☐ Cracked bowl ☒ Continuous Running

Toilet water runs which is an indication that water valves, flappers or other components are in need of repair or replacement.

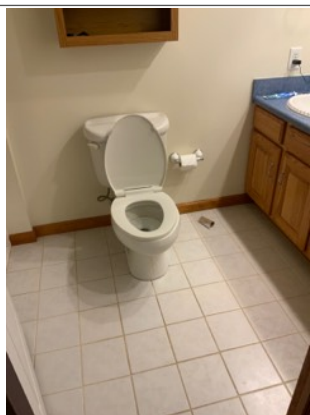
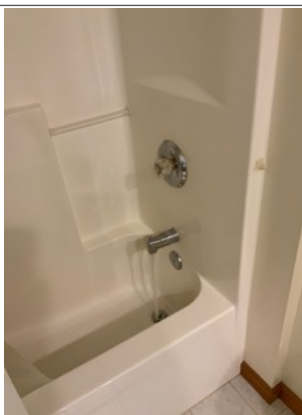
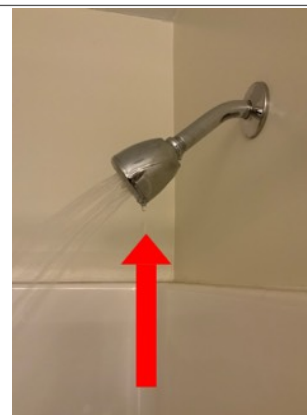
Comments Leaking showerhead fixtures should be repaired or replaced.

Leaking showerhead fixtures should be repaired or replaced.

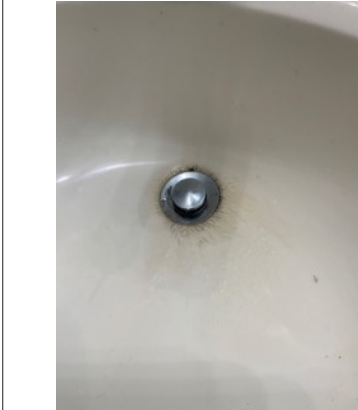
Master bath

Cracks/damage wash basin
master bathroom was in need of
repairs.

Comments Chipped/damaged tub finish was in need of repairs to prevent worsening conditions or leaking issues. Cracks/damage washbasin master bathroom was in need of repairs.

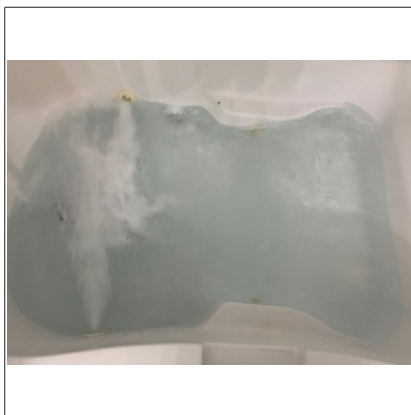
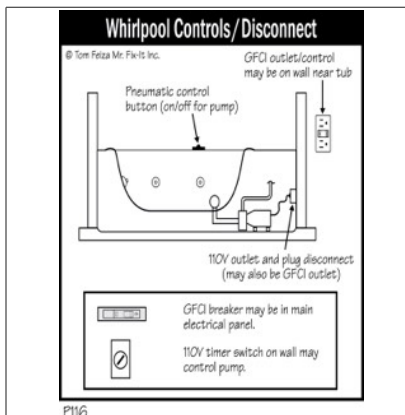
Shower/Tub area ☒ Ceramic/Plastic ☐ Fiberglass ☐ Masonite Other: Condition: ☐ Satisfactory ☒ Marginal
☐ Poor ☐ Rotted floors ☒ Chipped Tub Finish Caulk/Grouting needed: ☒ Yes ☐ No
 Where:
☐ N/A

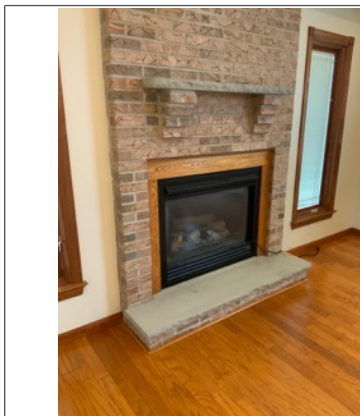
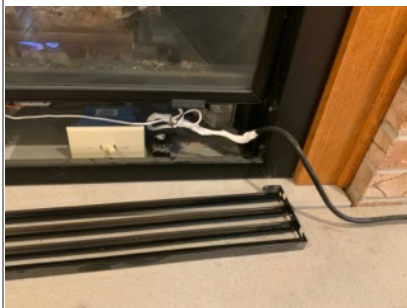
Comments Handyman extension cord wiring was observed for blower motor. This is not recommended for concerns of safety.

Handyman extension cord wiring is not recommended for concerns of safety. Repairs are recommended.

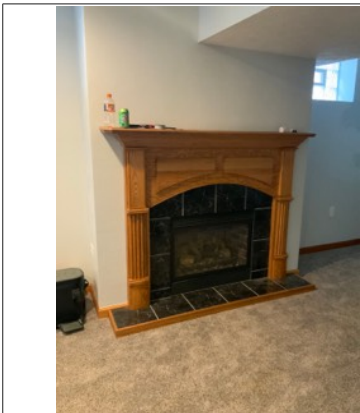
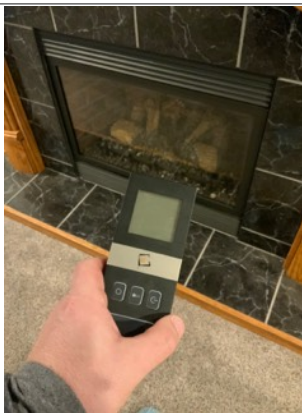
Comments Remote start for family room gas fireplace was lacking functional batteries. This restricted testing and should be further evaluated before closing to ensure proper operation.

Remote start for family room gas fireplace was lacking functional batteries. This restricted testing and should be further evaluated before closing to ensure proper operation.

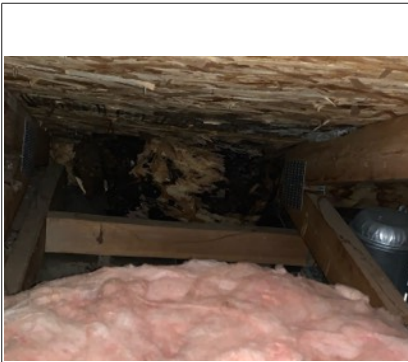
Moisture entry was found at the north eave. Sagging roof sheathing wood rot and deterioration was documented. Water streaking and staining was found on the soffit eave. Recommend consulting with a qualified roofing contractor for appropriate repairs deemed necessary before closing.

Comments Evidence of roof leakage was observed on the underside of the roof sheathing near north eave. **These areas were wet and appeared active at the time of the inspection.** Further evaluation and repairs are recommended.

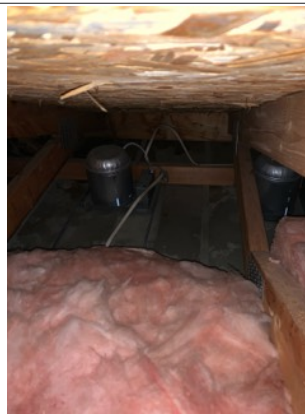
Moisture entry was found at the north eave. Sagging roof sheathing wood rot and deterioration was documented. Water streaking and staining was found on the soffit eave. Recommend consulting with a qualified roofing contractor for appropriate repairs deemed necessary before closing.

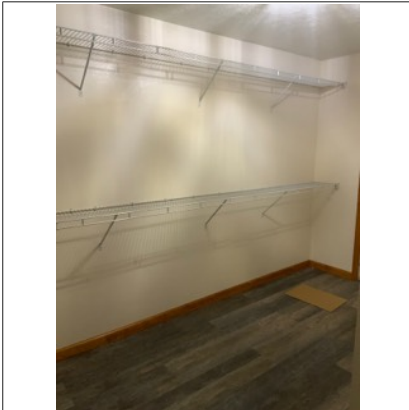
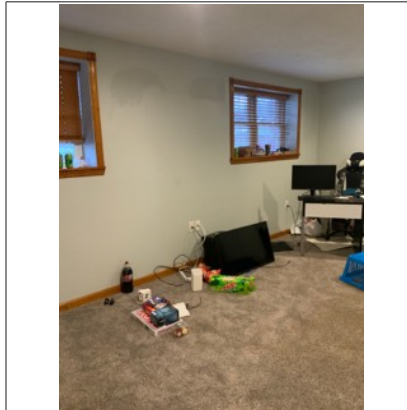
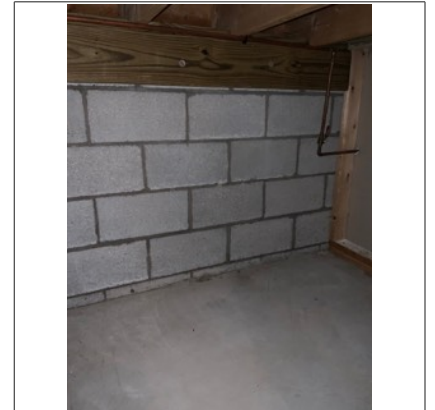
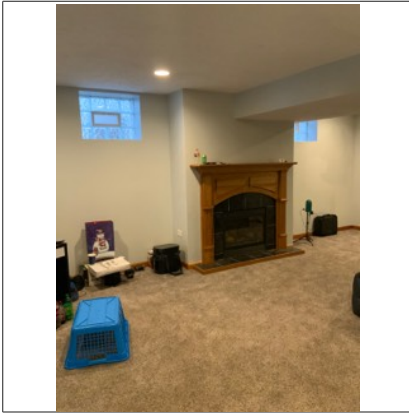
Comments Foundation walls were covered with paneling/drywall and were not fully visible.

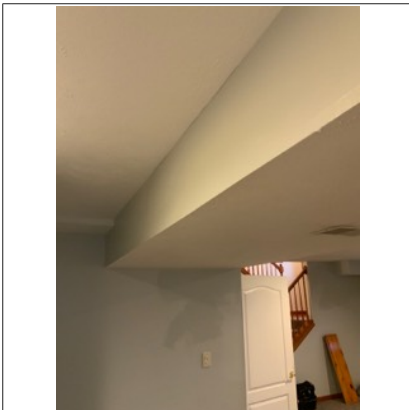
Condition ☒ Not Visible
☒ Satisfactory ☐ Marginal ☐ Poor ☐ Stained/Rusted
Material ☒ Steel ☐ Wood ☐ Concrete ☐ LVL ☐ Not Visible
Comments Unfinished portions of the basement ceiling showed the support beam in overall adequate condition.
Photos

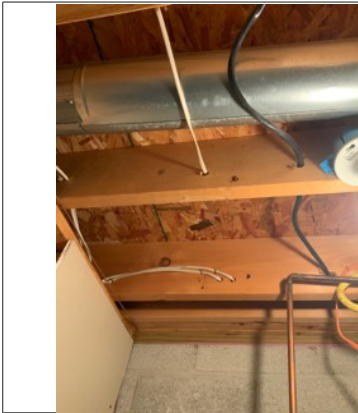
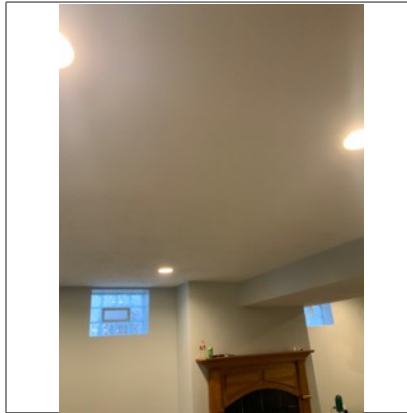
☐ Not Visible
☒ Satisfactory ☐ Marginal ☐ Poor
☒ Wood ☐ Steel ☐ Truss ☐ Not Visible ☐ 2x8 ☒ 2x10 ☐ 2x12 ☐ Engineered I-Type
☐ Sagging/altered joists
Comments Unfinished portions of the basement ceiling showed the floor joists in overall adequate and satisfactory condition.

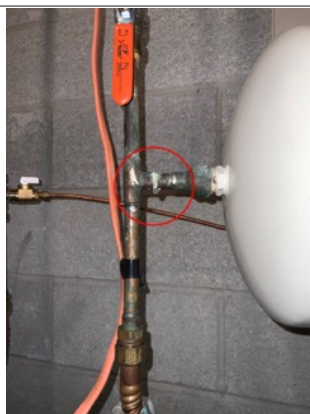
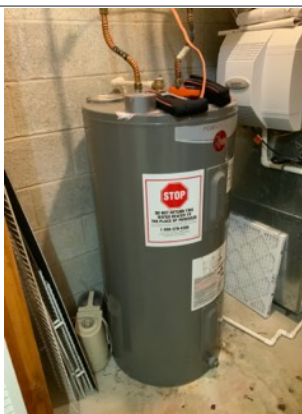
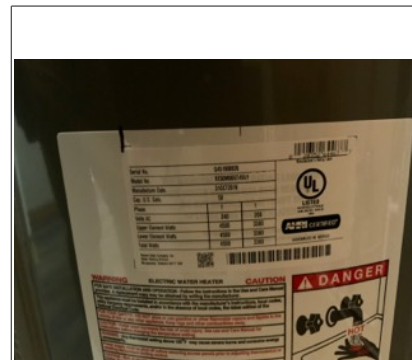
Leakage around water heating equipment water supply connections was observed. Leaking water heater water supply connections may cause water damage and should be repaired or replaced as needed by a certified, licensed water heating equipment specialist.

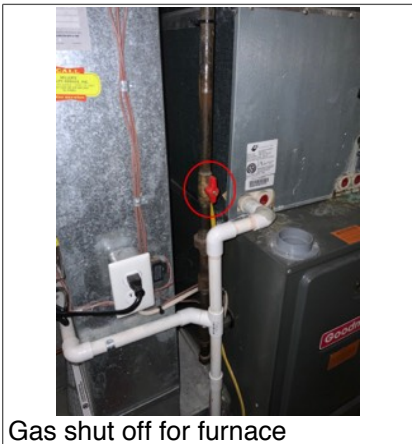
Visible rust was observed in the heating chamber. This rust is often found in older furnaces. To improve efficiency it is recommended to have a qualified HVAC technician clean and adjust the furnace.

Heating equipment showed signs of being dirty and a lack of maintenance. Improperly maintained heating equipment may not perform as intended. The inspector recommends cleaning, servicing, and further evaluation of the heating equipment by a licensed professional.

This was lacking a proper power disconnect and should be added by a qualified HVAC technician.

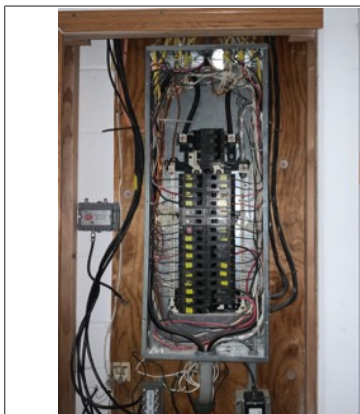
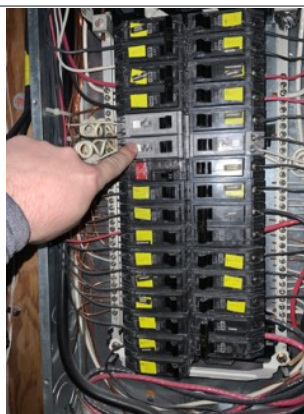
Arc-fault breakers were not operating properly, won't trip, recommend replacing.

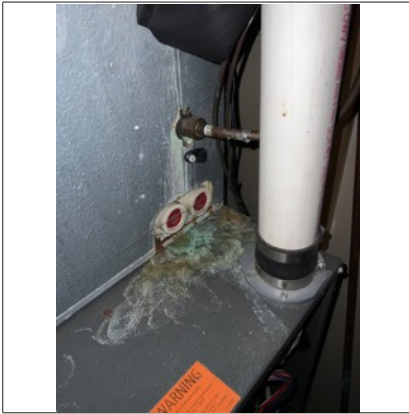
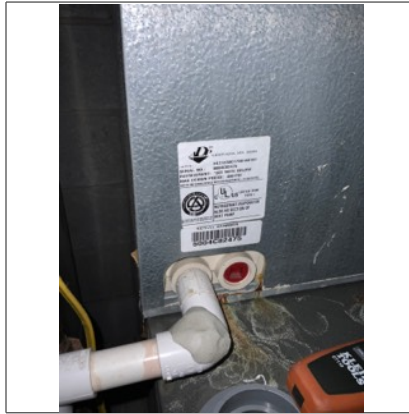
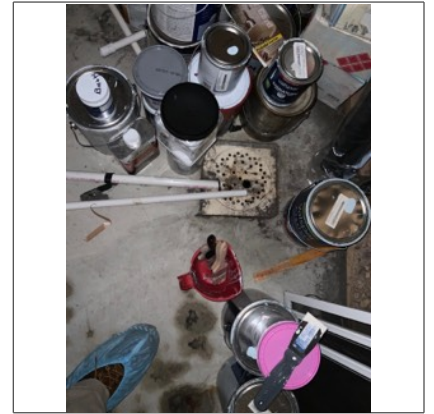
Refrigerant line showed signs of previous leaks. Recommend consulting with the seller regarding previous repairs. It is recommended service and clean HVAC equipment.
